**Flood Control Project Maintenance
Levee Inspections**
LMA District Cover Sheet
Spring 2020 Levee Inspection Results

Reclamation District No. 2058 Pescadero

Levee Inspection Report By Mile - Spring 2020

Waterway	Bank	Unit Miles	Inspection Start/End	Inspector
Unit No. 01 Paradise Cut	Left	6.58	03/11/2020 03/11/2020	Alberto De Leon

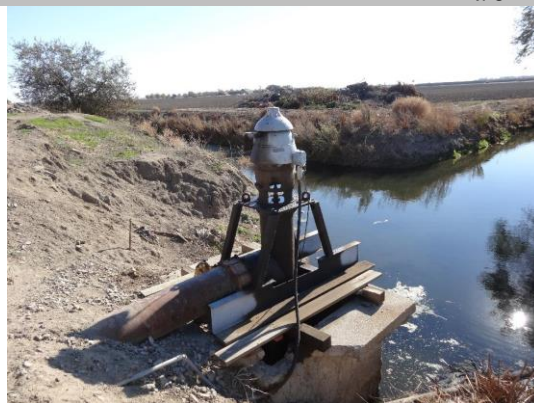
Photo 1 of 3 : UCIP_SP_2020_45843_45165.jpg

LM Start	0.72	Rating **	M	Issue No.	975	
LM End	0.72	Issue Type +	En	Location *		
Category	Supplemental			GPS Latitude/Longitude		
				Start		End
Item	DWR UCIP Field Study			37.801792 °		37.801792 °
				-121.410921 °		-121.410921 °
DWR ID	22700

Comment Code						
Inspector Comment						
DS_ID:22700 FS_ID:45843 EP_NO: 5055 Repair Type: Non-Urgent Crossing Status: Found UCIP Comments: Excessive oil leakage. FIELD_STRUCT_DESC: 16-inch steel drainage discharge pipe through the levee, 3.8 feet below the crown. Drainage ditch on the landside (LS). Pump on a concrete sump on the LS. Siphon breaker under protective cover on the waterside (WS) slope. (To abandon the existing 12-inch pipe with concrete and install a new 16-inch pipe authorized under Permit No. 5055, 1965 - Stanley Electric Motor Company). 12-inch pipe grouted in place. [Additional Reference(s): DWR Levee Log, 2005. USACE San Joaquin O&M Manual 10, March 1964, (HLM 0.72)]. FS Date: 5/12/2015

LS view: exposed pipe and vertical pump on concrete sump on drain ditch.

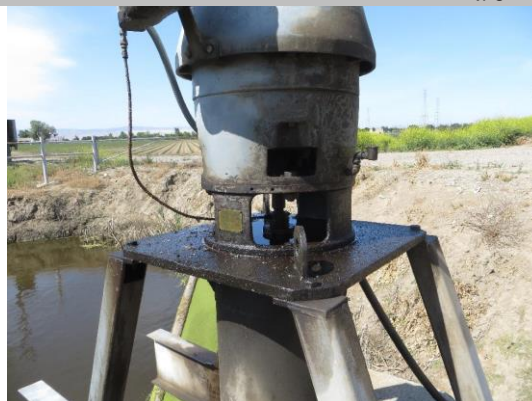
Photo 2 of 3 : UCIP_SP_2020_45843_74061.jpg

LS view: closeup of pump showing excessive oil leakage.

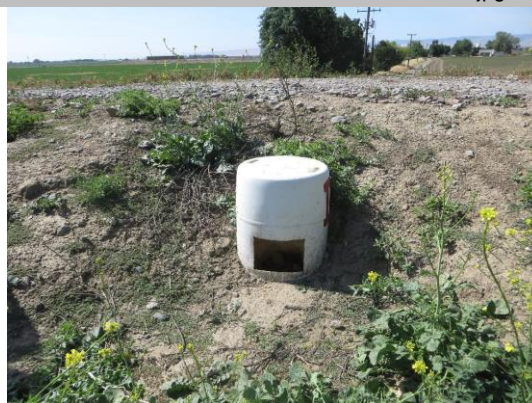
Photo 3 of 3 : UCIP_SP_2020_45843_74060.jpg

WS view: siphon breaker in protective casing.

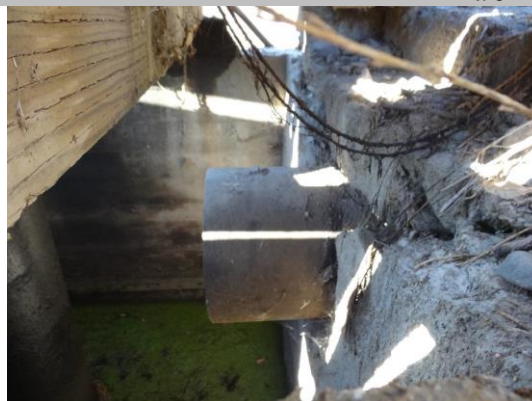
Photo 1 of 1 : UCIP_SP_2020_53531_45168.jpg

Comment Code						
Inspector Comment						
DS_ID:22704 FS_ID:53531 EP_NO: N/A Repair Type: No Action Needed Crossing Status: Found UCIP Comments: 12/07/2018 Need updated photos to show proper 12-inch pipe abandonment. If crossing was abandoned properly crossing will need to be removed from the LMA responsibility list. Also recommend updating photos for dsid 22700 (16-inch pipe) authorized under the same permit. (O. Magana - DWR UCIP) FIELD_STRUCT_DESC: *ABANDONED* 12-inch drainage discharge pipe of an unknown material through the levee, 18 feet below the crown. Pump on the landside (LS). Flap gate on the waterside (WS). (To abandon the existing 12-inch pipe with concrete and install a new 16-inch pipe authorized under Permit No. 5055, 1965 - Stanley Electric Motor Company). 12-inch pipe grouted in place. [Additional Reference(s): DWR Levee Log, 2005. USACE San Joaquin O&M Manual 10, March 1964, (HLM 0.72)]. FS Date: 5/12/2015

LS view: an abandoned pipe found in concrete sump.

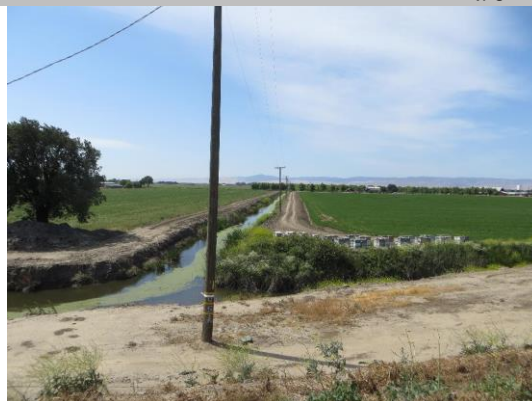
Photo 1 of 1 : UCIP_SP_2020_45847_74322.jpg

LM Start	1.21	Rating **	M	Issue No.	977	
LM End	1.21	Issue Type +	En	Location *		
Category	Supplemental			GPS Latitude/Longitude		
				Start	End	
Item	DWR UCIP Field Study			37.802249 °	37.802249 °	
				-121.402183 °	-121.402183 °	
DWR ID	22693					
Comment Code						
Inspector Comment						
DS_ID:22693						
FS_ID:45847						
EP_NO: 10426						
Repair Type: Non-Urgent						
Crossing Status: Indicator Found						
UCIP Comments: Crossing needs to be marked.						
FIELD_STRUCT_DESC: 33-inch concrete encased steel sewer line through the levee, 17 feet below the crown. Manholes visible along Delta Avenue, but no other indicators visible at the levee. (Sewer line authorized under Permit No. 10426, 1975 - City of Tracy, care of CDM, Inc.). [Additional Reference(s): DWR Levee Log, 2005].						
FS Date: 5/12/2015

View of LS. Alignment of Crossing to right of canal at dirt access road.

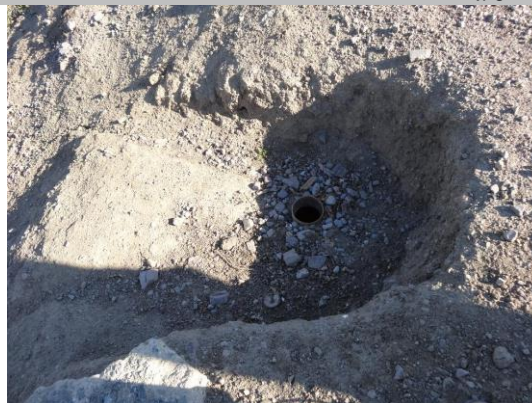
Photo 1 of 3 : UCIP_SP_2020_53374_45171.jpg

LM Start	1.22	Rating **	U	Issue No.	978	
LM End	1.22	Issue Type +	En	Location *		
Category	Supplemental			GPS Latitude/Longitude		
				Start	End	
Item	DWR UCIP Field Study			37.802301 °	37.802301 °	
				-121.401977 °	-121.401977 °	
DWR ID	22694

Comment Code						
Inspector Comment						
DS_ID:22694 FS_ID:53374 EP_NO: 11546 Repair Type: Urgent Crossing Status: Found UCIP Comments: 10/12/2018 Same as last inspection; keeping as Urgent due to erosion into levee prism (D. Sanoski - DWR UCIP).11/29/2016 Heavy erosion still present. Could be due to wave run-up as this is the only spot on levee not rock revetted. Greg Pombo (RD2058) indicated permits for endangered species prevent rock revetment. (K. Fazel - UCIP)05/12/2015 Erosion on west side of pipe at W/S toe. (K. Fazel - UCIP) FIELD_STRUCT_DESC: 1 of 2: 18-inch steel drainage discharge pipe through the levee, 2 feet below the crown. Pump in drainage ditch on the landside (LS). Siphon breaker with cover on the waterside (WS) shoulder. Electrical service pole at the LS toe. (18-inch pipe and pump authorized under Permit No. 11546, 1976 - Reclamation District No. 2058). [Additional Reference(s): DWR Levee Log, 2005]. FS Date: 10/12/2018 9:59:00 AM

WS view: siphon breaker hole. Siphon breaker removed for repair.

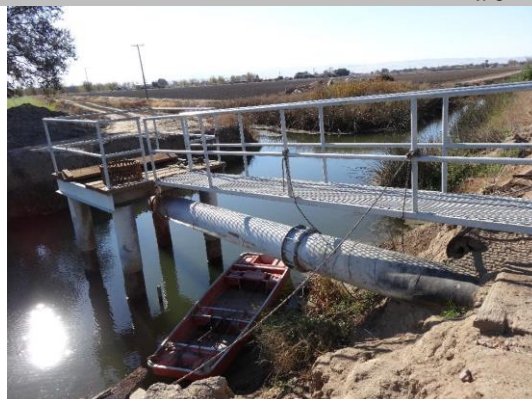
Photo 2 of 3 : UCIP_SP_2020_53374_45170.jpg

LS view: pipe, pile structure, and pump platform in drain ditch.

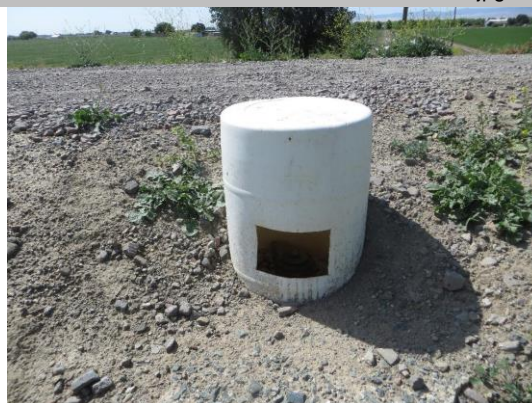
Photo 3 of 3 : UCIP_SP_2020_53374_74320.jpg

Siphon Breaker on WS shoulder.

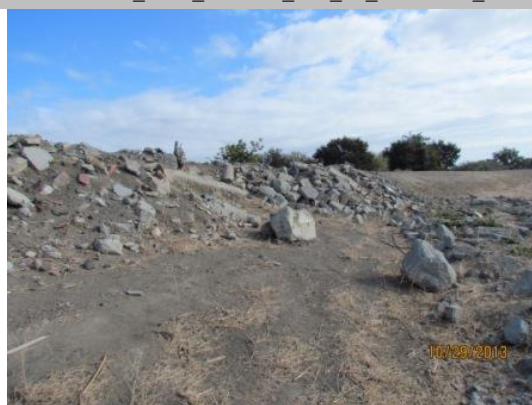
Photo 1 of 1 : SP_2020_RD2058_111_11_20200228_00005.jpg

LM Start	1.82	Rating **	M	Issue No.	11
LM End	1.83	Issue Type +	En	Location *	LS
Category	Earthen Levee			GPS Latitude/Longitude	
				Start	End
Item	Encroachments			37.804785 °	37.804802 °
				-121.391524 °	-121.391304 °
DWR ID	DWR_RD2058_01_f_2013_11				
Comment Code					
DE : Debris					
Inspector Comment					
Land owner has been removing concrete rubble from landside slope. Landowner will continue the clean up process until completed.

View of the concrete with rebar placed on the landside slope.

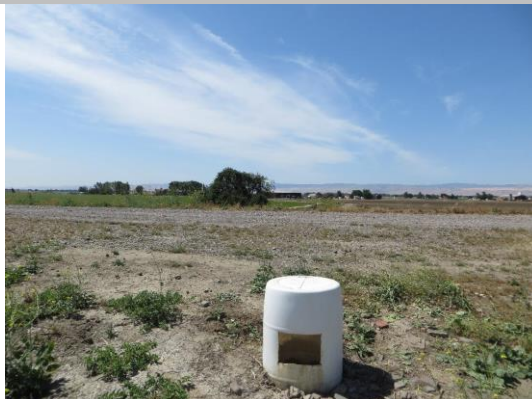
Photo 1 of 3 : UCIP_SP_2020_45865_74323.jpg

LM Start	2.12	Rating **	A/W	Issue No.	979
LM End	2.12	Issue Type +	Ma	Location *	
Category	Supplemental			GPS Latitude/Longitude	
				Start	End
Item	DWR UCIP LMA Responsibility			37.803892 °	37.803892 °
				-121.386299 °	-121.386299 °
DWR ID	22705				
Comment Code					
Inspector Comment					
DS_ID:22705 FS_ID:45865 EP_NO: N/A Repair Type: No Action Needed Crossing Status: Found UCIP Comments: FIELD_STRUCT_DESC: 20-inch steel drainage discharge pipe through the levee, 8 feet below the crown. Pump on a concrete sump in a drainage ditch on the landside (LS) toe. Siphon breaker on the waterside (WS) shoulder. [Additional Reference(s): USACE San Joaquin O&M Manual 10, March 1964, (HLM 2.14), 18-inch pipe referenced]. FS Date: 5/12/2015

Siphon breaker on WS shoulder inside protective riser.

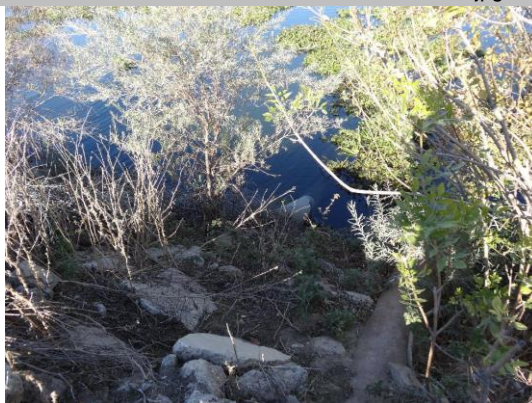
Photo 2 of 3 : UCIP_SP_2020_45865_74324.jpg

Pipe just visible at WS toe at center of photograph.

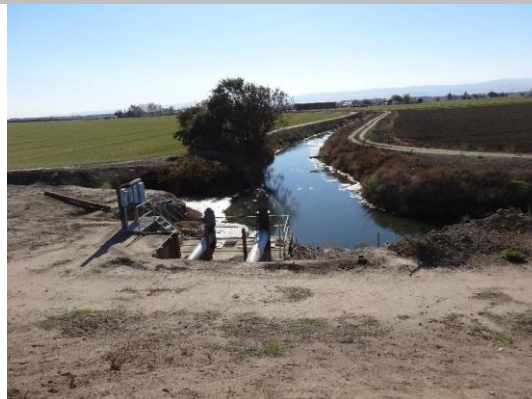
Photo 3 of 3 : UCIP_SP_2020_45865_74325.jpg

Pump on concrete pad at LS toe.

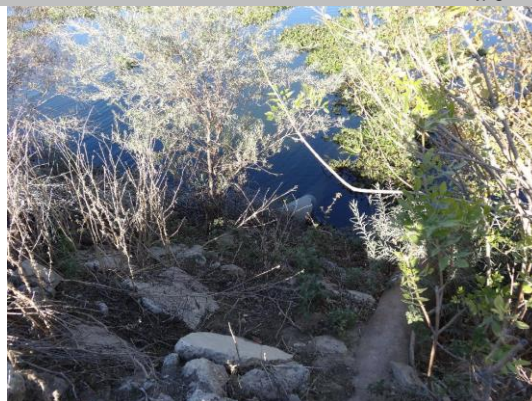
Photo 1 of 3 : UCIP_SP_2020_51699_45192.jpg

DS_ID:22706
 FS_ID:51699
 EP_NO: N/A
 Repair Type: Non-Urgent
 Crossing Status: Found
 UCIP Comments: Leaky and damaged siphon breaker on waterside shoulder..
 FIELD_STRUCT_DESC: 16-inch steel drainage discharge pipe through the levee, 8 feet below the crown. Pump on a concrete sump in a drainage ditch on the landside (LS) toe. Siphon breaker on the waterside (WS) shoulder. [Additional Reference(s): USACE San Joaquin O&M Manual 10, March 1964, (HLM 2.14), 12-inch pipe referenced].
 FS Date: 5/13/2015

WS view: exposed steel pipe (right) on channel bank.

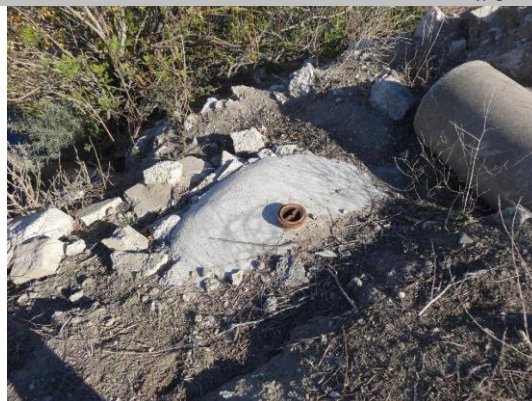
Photo 2 of 3 : UCIP_SP_2020_51699_45191.jpg

WS view: siphon breaker on concrete pad on levee slope.

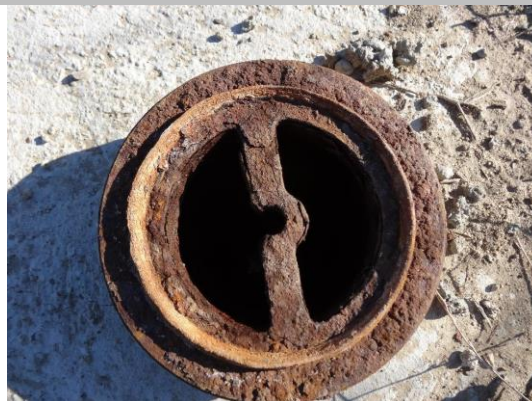
Photo 3 of 3 : UCIP_SP_2020_51699_45190.jpg

WS view: Upper part of the siphon breaker missing.

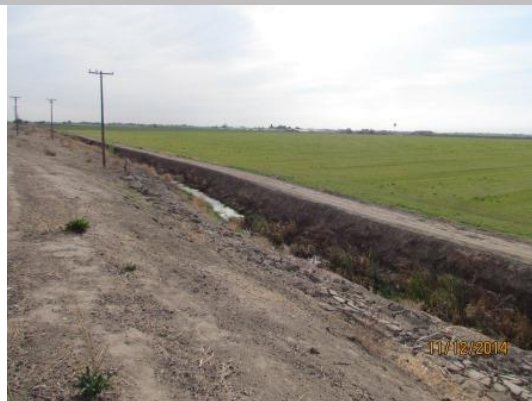
Photo 1 of 1 : SP_2020_RD2058_111_12_20200228_00006.jpg

LM Start	2.24	Rating **	M	Issue No.	12
LM End	2.30	Issue Type +	En	Location *	LS
Category	Earthen Levee			GPS Latitude/Longitude	
				Start	End
Item	Encroachments			37.803375 °	37.803136 °
				-121.384196 °	-121.383078 °
DWR ID	DWR_RD2058_01_f_2013_12				
Comment Code					
DT : Ditch					
Inspector Comment

View of the ditch at the landside levee toe.

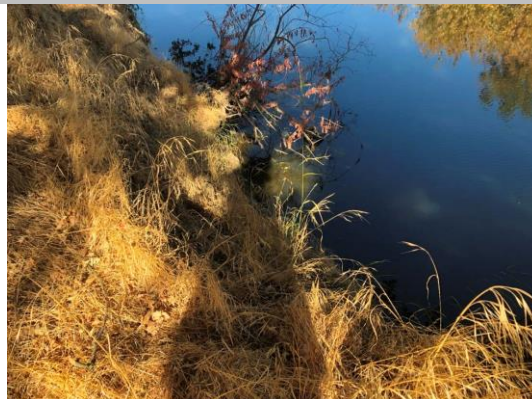
Photo 1 of 3 : SP_2020_RD2058_111_1_20200228_00001.jpg

Site ID: RD2058U01RM3.97
 09/25/2019: No significant change observed.
 10/10/2017: No significant change observed.
 07/20/2016: No significant change observed.
 08/04/2015: No significant change observed.
 08/26/2014: No significant change observed.
 08/28/2013: No significant change observed.
 07/26/2012: The site has been visited, and no significant change has been observed.
 09/02/2011: This site was not visited due to the time limit.
 09/22/2010: No significant change observed. Minor pocket erosions are lined at the lower bank. Two large Oak and Willow trees are on mid-slope and bench. The remaining bench was re-measured and found to be approximately 10 feet. There was no indication of active erosion on site during the site visit.
 08/05/2010: Recommended for annual assessment and monitoring of the site during flood events, per CLRO.
 07/23/2009: No major change observed since last visit; site is a 200-ft. long near-vertical berm erosion; recommend annual assessment and monitoring of the erosion site, per CLRO CES Evaluation 2008 Report; Site # is the same site previously reported as RM4.0, LM4.51; previously rated "U".

Direct view of the pocket erosion site.

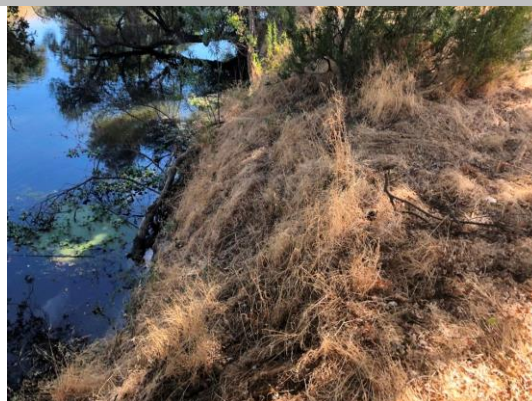
Photo 2 of 3 : SP_2020_RD2058_111_1_20200228_00002.jpg

Direct view of the erosion near a tree.

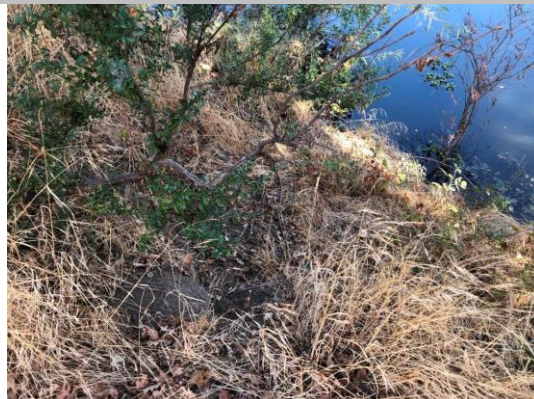
Photo 3 of 3 : SP_2020_RD2058_111_1_20200228_00003.jpg

Close-up view of the erosion.

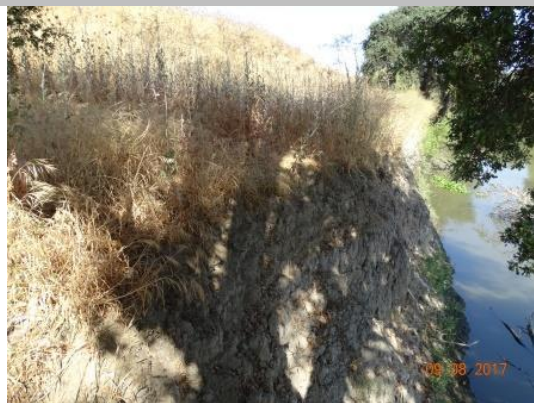
Photo 1 of 2 : SP_2020_RD2058_111_40_20200228_00022.jpg

LM Start	4.63	Rating **	U	Issue No.	40
LM End	4.76	Issue Type +	Ma	Location *	WS
Category	Earthen Levee			GPS Latitude/Longitude	
				Start	End
Item	Erosion / Bank Caving			37.787756 °	37.785971 °
				-121.350851 °	-121.350372 °
DWR ID	DWR_RD2058_01_f_2017_40				
Comment Code					
E2 : Schedule repair of erosion site prior to the next inspection.					
Inspector Comment					
Erosion on the waterside is greater than three feet tall into the levee prism. This is a 2017 Storm Damage site: Site ID No:82 Site Designation: LMA-36, listed as an area of concern.

Downstream view of the erosion.

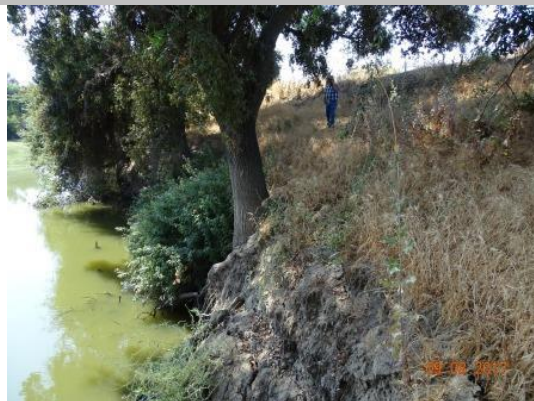
Photo 2 of 2 : SP_2020_RD2058_111_40_20200228_00024.jpg

Upstream view of the erosion site.

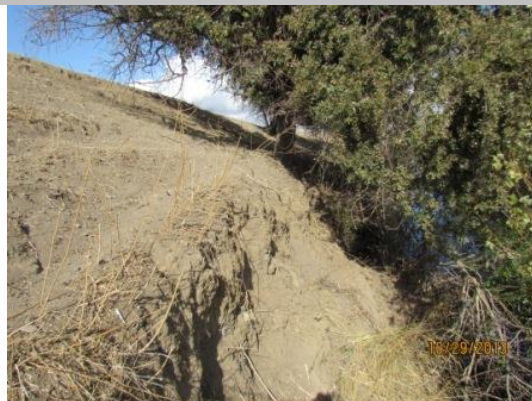
Photo 2 of 3 : SP_2020_RD2058_111_44_20200312_00056.jpg

LM Start	4.77	Rating **	A/W	Issue No.	44	
LM End	4.77	Issue Type +	Ma	Location *	WS	
Category	Supplemental			GPS Latitude/Longitude		
				Start	End	
Item	2017 Storm Damage			37.785862 °		°
				-121.350303 °		°
DWR ID	DWR_RD2058_01_s_2020_44					
Comment Code						
Inspector Comment						
Plan for repair, term of agreement is through end date Dec. 31, 2020						
FSRP:Levee Evaluation Comments						
Description:						
Site ID No:100						
Site Designation:FSRP-14-25						
Repair Type: Erosion						
Rating:Area of Concern						
Field Date:6/8/2017						
Notes: vegetation too dense to evaluate damage. The erosion has about a 3 foot vertical cut at the waterside levee toe as of the Fall 2017 Inspection. Turned back over to Evaluators for re-assessment

View of erosion at the waterside levee toe.

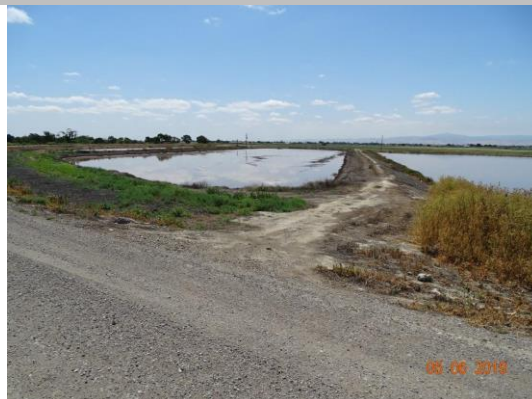
Photo 1 of 1 : SP_2020_RD2058_111_35_20200228_00019.jpg

View of ramp on landside slope providing access from dairy farm to levee crown. (Spring 2019)

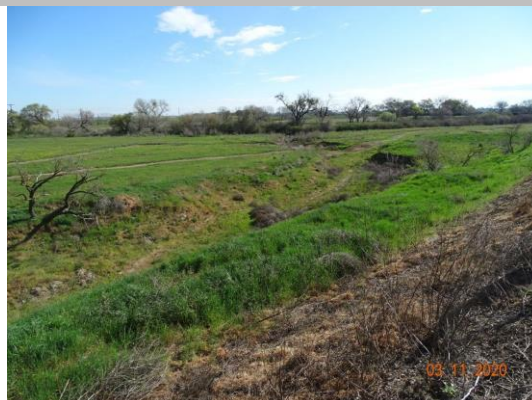
Photo 1 of 1 : SP_2020_RD2058_111_33_20200312_00059.jpg

LM Start	5.71	Rating **	U	Issue No.	33
LM End	5.71	Issue Type +	Ma	Location *	WS
Category	Earthen Levee			GPS Latitude/Longitude	
				Start	End
Item	Erosion / Bank Caving			37.777735 °	37.777735 °
				-121.338103 °	-121.338103 °
DWR ID	DWR_RD2058_01_s_2017_33				
Comment Code					
E2 : Schedule repair of erosion site prior to the next inspection.					
Inspector Comment					
The approximate 10 foot berm is eroding towards the levee slope.

View of waterside bank erosion looking upstream. Spring 2020

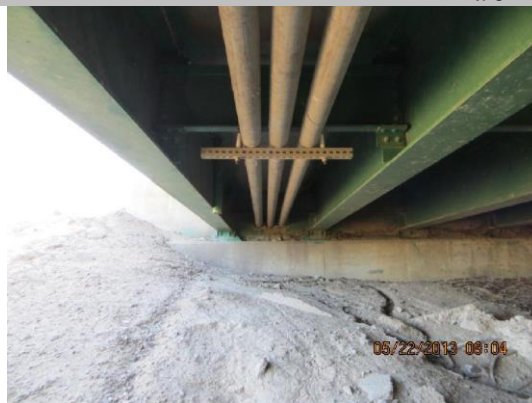
Photo 1 of 3 : UCIP_SP_2020_45871_73100.jpg

Comment Code						
Inspector Comment						
DS_ID:22701						
FS_ID:45871						
EP_NO: 13262						
Repair Type: Non-Urgent						
Crossing Status: Indicator Found						
UCIP Comments: Owner needs to install signs at crossing.						
FIELD_STRUCT_DESC: 1 of 3: 4-inch concrete encased polyvinyl chloride (PVC) electrical conduit through the levee, 3 feet below the crown. Signs on both banks of the levee. Manholes on both sides of Manthey Road. Pipes visible under Manthey Road bridge. (To install three 4-inch concrete encased PVC electrical conduits through the levee authorized under Permit No. 13262, 1981 - Pacific Telephone and Telegraph Company [PT&T]).						
FS Date: 5/13/2015

Pipes visible under Manthey Rd Bridge at Paradise Cut.

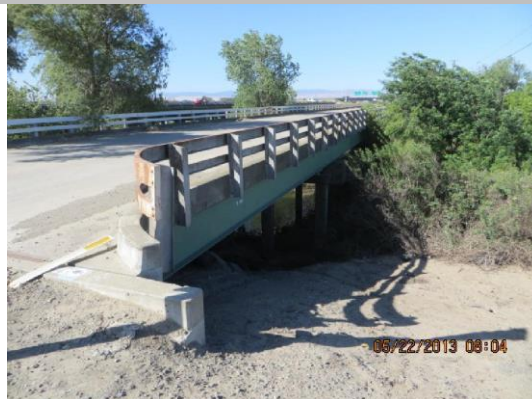
Photo 2 of 3 : UCIP_SP_2020_45871_73101.jpg

Pipes visible under Manthey Rd Bridge at Paradise Cut.

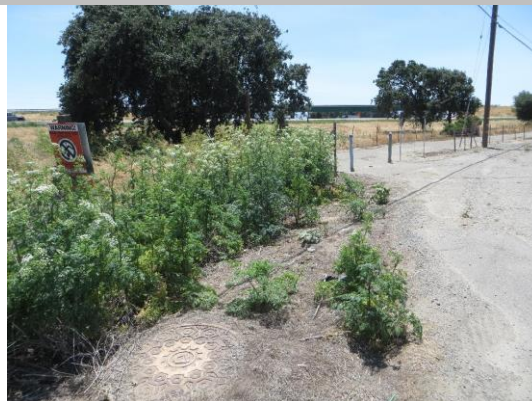
Photo 3 of 3 : UCIP_SP_2020_45871_74132.jpg

Comm sign and Pac Bell manhole appr. 600 ft from LS toe.

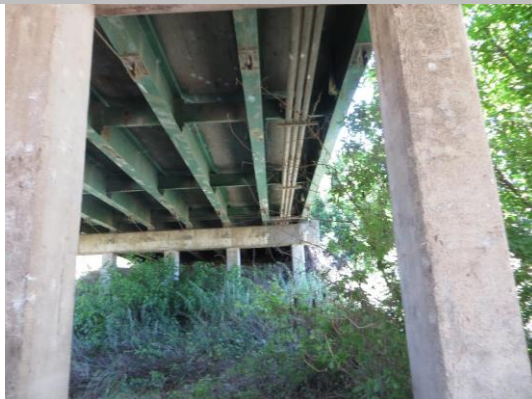
Photo 1 of 3 : UCIP_SP_2020_45768_74267.jpg

Comment Code						
Inspector Comment						
DS_ID:25077						
FS_ID:45768						
EP_NO: 13262						
Repair Type: Non-Urgent						
Crossing Status: Indicator Found						
UCIP Comments: Owner needs to install signs at crossing.						
FIELD_STRUCT_DESC: 2 of 3: 4-inch concrete encased polyvinyl chloride (PVC) electrical conduit through the levee, 3 feet below the crown. Signs on both banks of the levee. Manholes on both sides of Manthey Road. Pipes visible under Manthey Road bridge. (To install three 4-inch concrete encased PVC electrical conduits through the levee authorized under Permit No. 13262, 1981 - Pacific Telephone and Telegraph Company [PT&T]).						
FS Date: 5/13/2015

Pipes visible under Manthey Rd Bridge at Paradise Cut

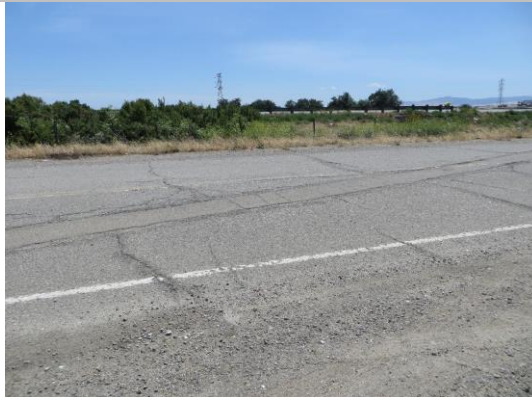
Photo 2 of 3 : UCIP_SP_2020_45768_74268.jpg

Cuts in pavement visible apprx. 450 ft from WS toe.

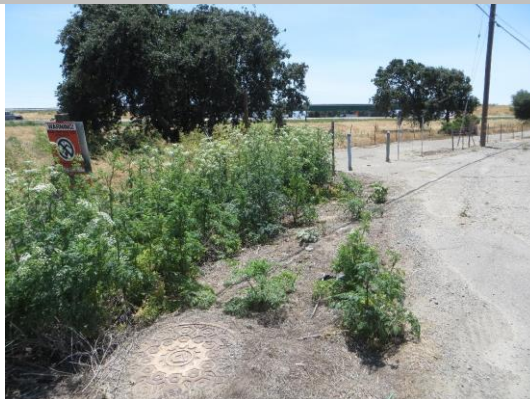
Photo 3 of 3 : UCIP_SP_2020_45768_74269.jpg

Comm sign and Pac Bell manhole appr. 600 ft from LS toe.

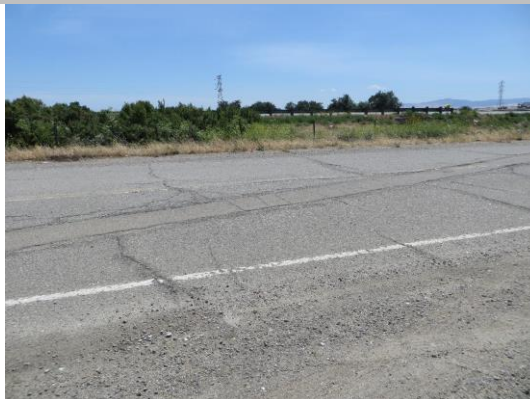
Photo 1 of 3 : UCIP_SP_2020_45769_74270.jpg

DS_ID:25078
 FS_ID:45769
 EP_NO: 13262
 Repair Type: Non-Urgent
 Crossing Status: Indicator Found
 UCIP Comments: Owner needs to install sign at crossing.
 FIELD_STRUCT_DESC: 3 of 3: 4-inch concrete encased polyvinyl chloride (PVC) electrical conduit through the levee, 3 feet below the crown. Signs on both banks of the levee. Manholes on both sides of Mantney Road. Pipes visible under Mantney Road bridge. (To install three 4-inch concrete encased PVC electrical conduits through the levee authorized under Permit No. 13262, 1981 - Pacific Telephone and Telegraph Company [PT&T]).
 FS Date: 5/13/2015

Cuts in pavement visible appr. 450 ft from WS toe.

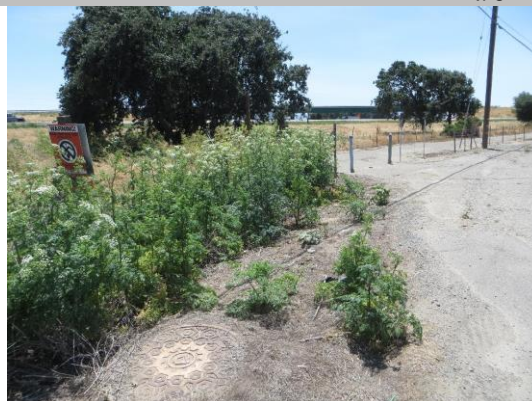
Photo 2 of 3 : UCIP_SP_2020_45769_74271.jpg

Comm sign and Pac Bell manhole appr. 600 ft from LS toe.

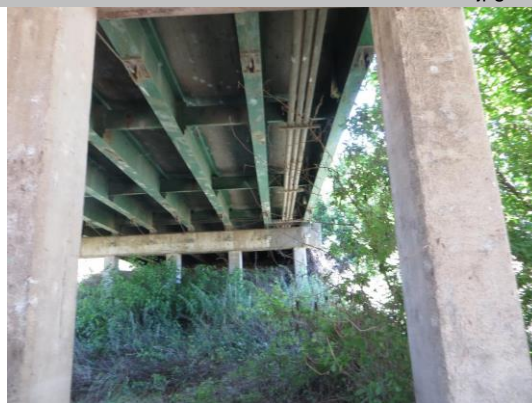
Photo 3 of 3 : UCIP_SP_2020_45769_74272.jpg

Pipes visible under Manthey Rd Bridge at Paradise Cut.
